# HYPOTHESIS OF EXPLOSION IN THE LEFT WING OUTER FUEL TANK OF TU-154M DUE TO ELECTRICAL IGNITION OF FUEL-AIR MIXTURE

Jacek F. Gieras

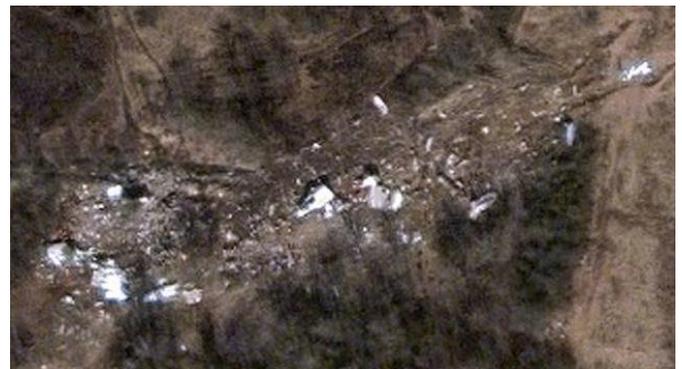
Fig. 1. Plane crash site on April 12, 2012. Source: Global Digital.

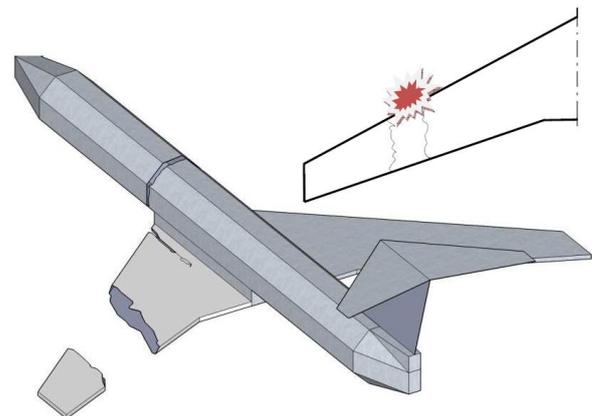
Fig. 2. Hypothesis of explosion in the left wing [16].

Since the severance of the wing tip as a result of collision with 0.3 to 0.4-m diameter birch tree is rather impossible, the problem should be stated in opposite way: *The burst of the left fuel tank Nr 3 caused lost of the left portion of the wing.*

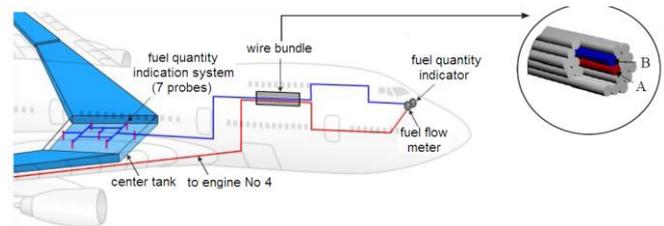
In older (and also many new) types of passenger aircraft electric wires belonging to different electric circuits are laid in common bundles [5,20]. It is economical solution, which reduces the cost of electrical wiring. On the other hand, ageing and deterioration of insulation, wire overheating, short circuit or electric arcing in one electric circuit can make damage to insulation and short circuit of wires belonging to other electric circuits. Thermal protections are sometimes not reliable. For example, short circuit in a bundle of electric wires caused ignition of fuel-air mixture in the center wing tank (CWT) of Boeing 747-131, flight TWA 800 on June 17, 1996 (Fig. 4). Burst of CWT led to destruction of the aircraft over the Atlantic Ocean [15].

Fig. 4. Wiring configuration on the Boeing 747. Investigators suspect that high voltage from the fuel flow meter A passed to the fuel quantity indication system (FQIS) B because of a short circuit in the wire bundle [15].

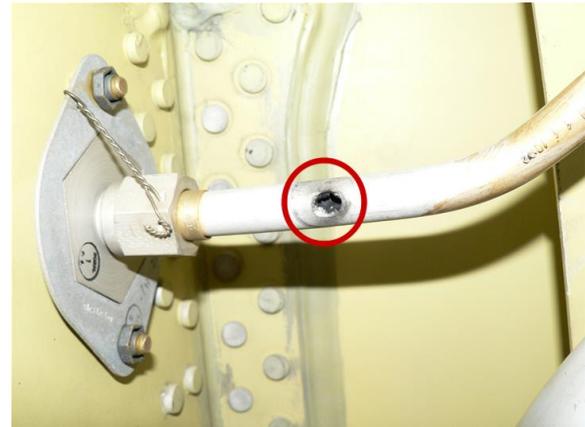
Explosion in the left wing fuel tank also took place on May 4, 2006 in Boeing 727-200 belonging to Malaysian Transmile Airline at Bangalore Airport, India [18]. Boeing 727 is very similar to Tu-154M. Explosion destroyed the structural integrity of the left wing. Investigators have found damaged electrical installation and electrical arcing in

aluminum tube with 115-V AC cable feeding fuel pump motor in the left wing tank (Fig. 5).

Rys. 5. Evidence of electrical arcing of the wiring inside the exploded fuel tank of Boeing 727-200, Transmile Airlines, Bangalore, May 4, 2006 [18].

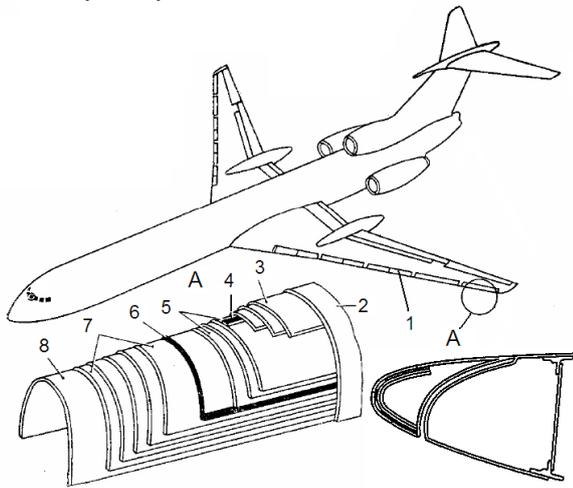
Malfunction of anti-ice electric heating system installed in slats (Fig. 9) could lead to local temperature rise in the tank wall and create friendly conditions for fuel ignition by sparks or arcing. Fuel vapor auto-ignition due to local hot spot in fuel tank, or temperature rise due to malfunction of anti-ice electric system or other electrical equipment/wiring is rather impossible, since the auto-ignition temperature of Jet A-1 fuel is 210°C (Table 3). More realistic is electrostatic charge build-up due to fuel flow and hazardous electric potential level inside the tank.

Although probability of explosion of fuel in the left wing tank No 3 due the electric short circuit, arcing or static electricity is low, this problem cannot be neglected in further investigation of the accident, especially examination of wreckage and its remaining electrical equipment and left wing fuel tank No 3. Careful attention should be given to fuel pumps, induction motors for fuel tanks, slat electric

anti-ice system, all power cables/wires in fuel tank No 3 and in its vicinity.
