# HYPOTHESIS OF EXPLOSION IN THE LEFT WING OUTER FUEL TANK OF TU-154M DUE TO ELECTRICAL IGNITION OF FUEL-AIR MIXTURE

Jacek F. Gieras

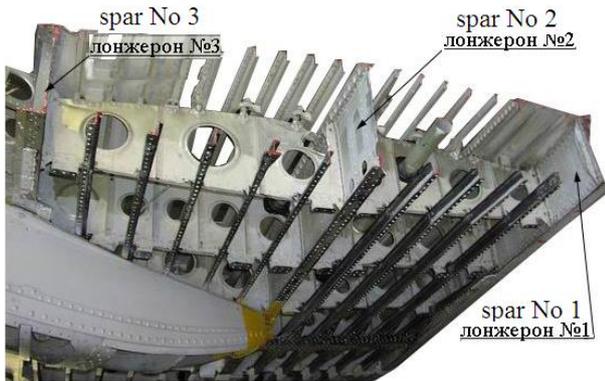
Fig. 3. Construction of Tu-154 wing [19].

The construction of Tu-154 wing is shown in Fig. 3. Its main parts are 3 spars, the upper and lower panels and 45 ribs. Wing ribs are perpendicular to the axis of the third spar. The chambers in their center parts are sealed and used as fuel tanks [1,17,19].

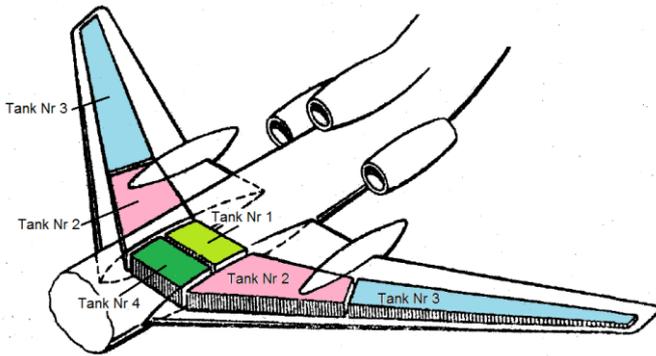
**Fig. 6. Tu-154M fuel tank configuration: Nr 1 – center wing tank (CWT), i.e., collector tank, Nr 2 – inner left and right wing tank, Nr 3 – outer left and right wing tank, Nr 4 – additional tank [17].**

Civil transport aircraft use the wing structure as an integral fuel tank to store fuel. In larger aircraft, the fuel is also stored in the structural wing box within the fuselage. A typical wing tank is irregular, long and shallow [11]. The fuel is in direct contact with the outside skin. Tu-154M has six fuel tanks: one central fuel tank (CWT) Nr 1, two inner wing tanks Nr 2, two outer wing tanks Nr 3 and one additional tank Nr 4. The Tu-154M fuel tank configuration is shown in Figs 6 and 7. Tanks Nr 3 are between spars 1 and 3 and ribs 14 and 45 of detachable parts of wings [17].

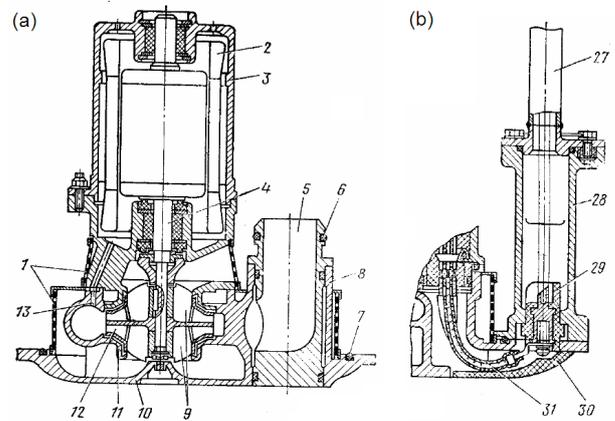
Fuel pumps of Tu-154M are driven by 115/220-V induction motors and DC 27 V brush motors (Table 1). Flange mounted motor and pump constitute one integral unit (Fig. 8a). The feeding cables in fuel tanks are in aluminum tubes (Fig. 8b). Arcing in wiring system that delivers electric energy to fuel pump motors can theoretically ignite the fuel-air mixture in the wing tank [2,9,11,12,13].
